NATIONAL REGISTER OF HISTORIC PLACES  
REGISTRATION FORM

historic name: The Botzum Farm

Botzum Farm  
Northampton Township  
Summit County, Ohio

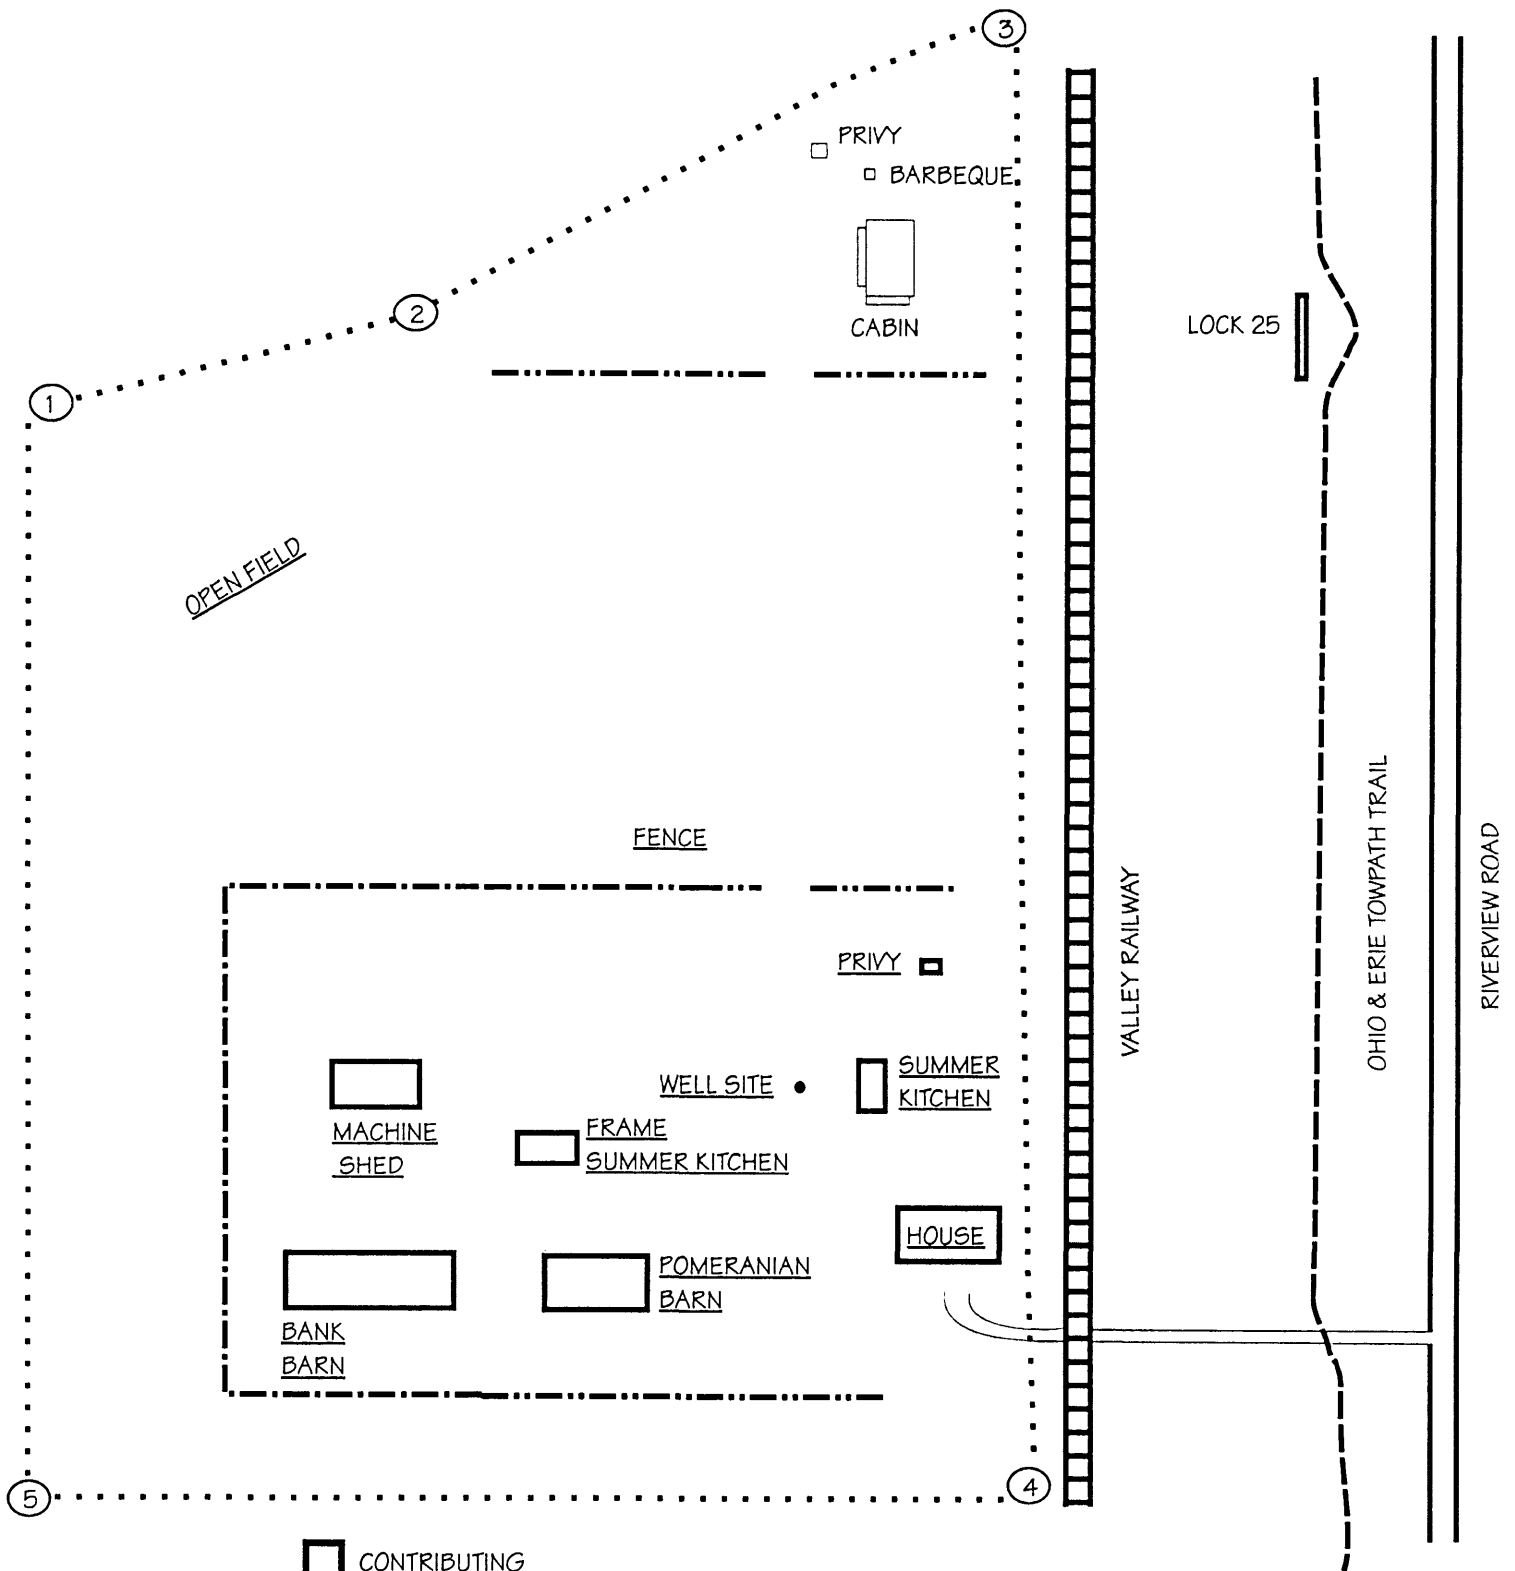
FIGURE ONE  
 SKETCH MAP  
BOTZUM FARMSTEAD  
 SUMMIT COUNTY, OHIO  
 NORTHAMPTON TOWNSHIP  
 OCTOBER 98  
 CUYAHOGA VALLEY  
 NATIONAL RECREATION AREA

The Botzum Farmstead is located in the southern end of the Cuyahoga Valley National Recreation Area and sets on a gently sloping outwash terrace in the western valley wall. The complex consists of ten contributing resources: seven buildings (house, privy, concrete block summer kitchen, frame summer kitchen, Pomeranian barn, machine shed, and raised bank barn), two structures (well site and fencing), and one historic site (the adjacent field). There are three noncontributing resources within the nominated area: two buildings (cabin and concrete block privy) and one structure (the barbecue grill) (see Figure 2).

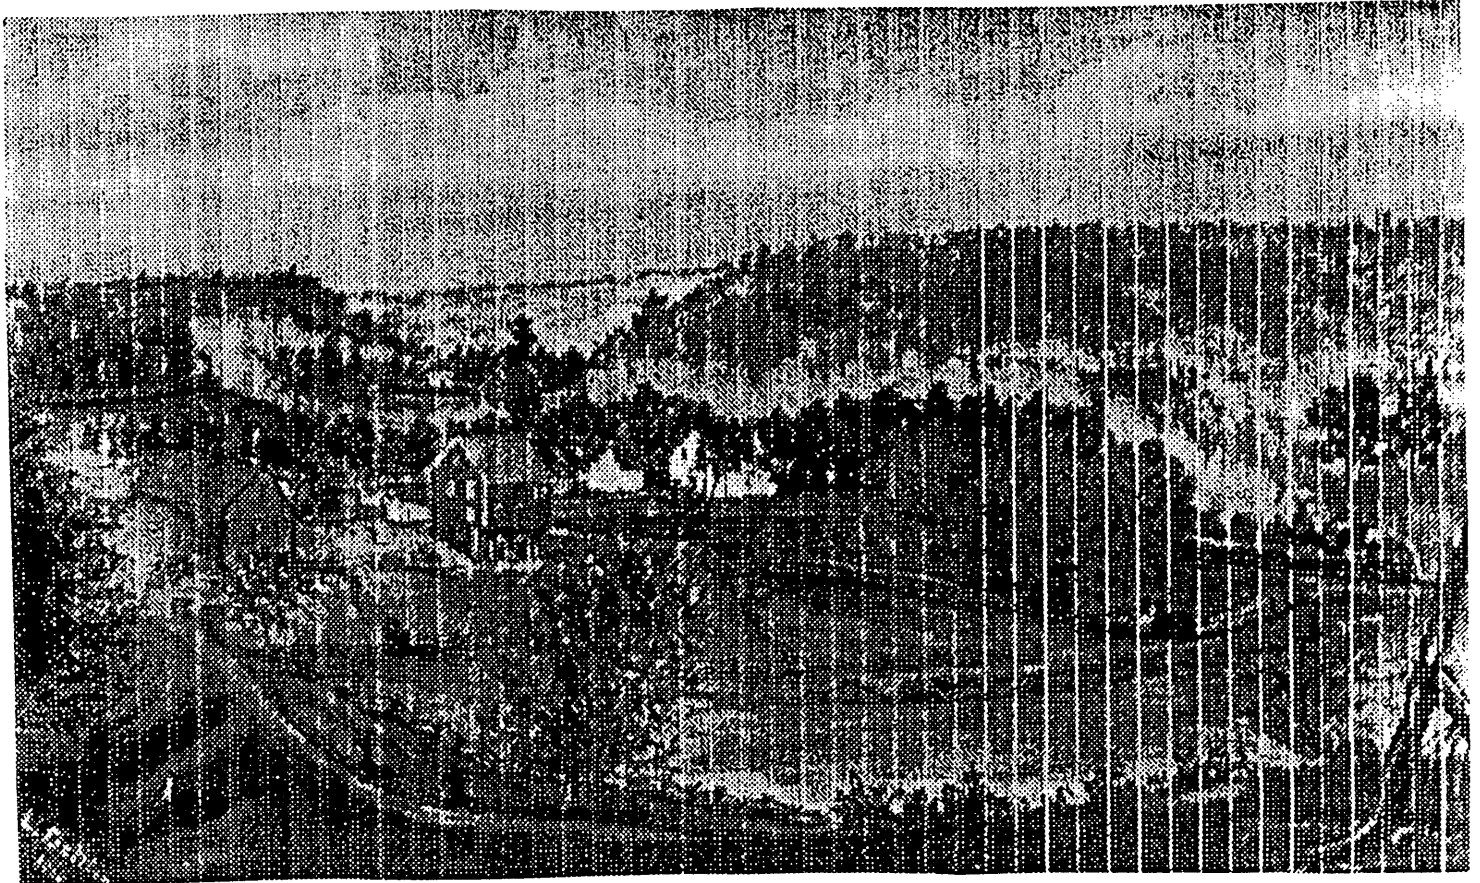
Figure 1  
Botzum Farm circa 1910  
By L. Dettling (1910)  
Northampton Township  
Summit County

granddaughter of Conrad Botzum depicts a farmstead set amidst rolling hills and delineated by wood post and rail or snake fences. The viewpoint of the farm appears to have been the hillside southwest of the farmstead. The two barns and the centrally located summer kitchen are easily recognized, although the orientation of the larger barn is skewed, perhaps due to the folk art nature of the painting. The house and adjacent building found in the painting are no longer standing, due to a fire in 1906.<sup>1</sup> An additional outbuilding is depicted along the driveway leading up to the property. It is not clear whether the dark building between the two barns is the machine shed; it appears smaller than the current structure. The cabin is not depicted.

below. It is interesting to note that the depiction of this barn in the 1910 painting does not show posts supporting the forebay, giving it the appearance of a Sweitzer Forebay barn rather than a Pomeranian barn.

The frame Summer Kitchen is apparent in a 1925 photograph of the farm and the 1910 painting. Defining elements of the type in evidence include frame construction, rectangular massing, and location behind the farmhouse.
