**NATIONAL REGISTER OF HISTORIC PLACES
INVENTORY -- NOMINATION FORM**

HISTORIC Daniel Tilden house

Tilden, Daniel, House, Peninsula, Summit County, Ohio

These drawings were prepared during the spring of 1983 by the following architectural students of Kent State University: Bob Orovets, Tony McBride, and Craig Curtis. The originals are on file at Cuyahoga Valley National Recreation Area.

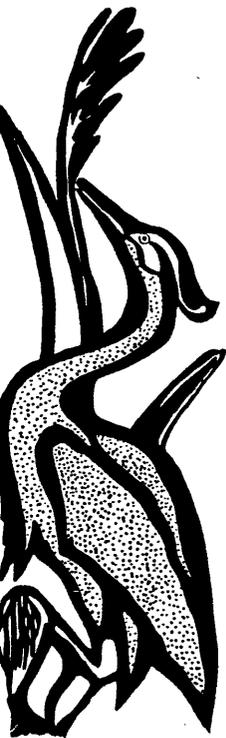
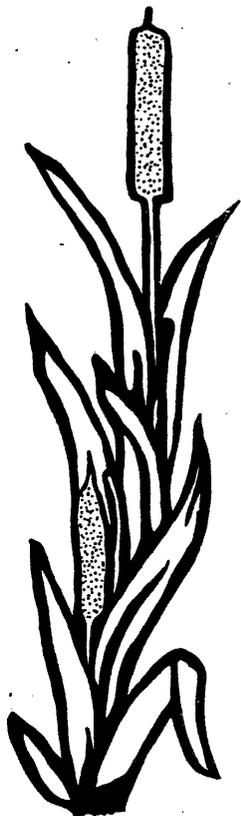
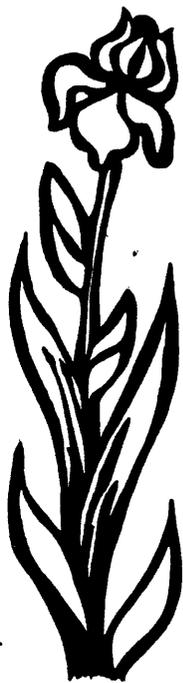
1 TYPICAL MOLDING CARVINGS
1/2" = 1'-0"

NOTE THESE CARVINGS ARE THE TWO CARVINGS IN THE HOUSE ARE ALIKE

With the exception of the additions mentioned above, the interior plan configuration has not been altered. Each doorway and window is framed in an elaborate casing of decorative white oak. The wood is purported to have been cut from the site, sawn in Cleveland, and then carved back on the site. The bases of many of these massive casings feature hand-carved and wood-burned depictions of natural scenes (birds, flowers, etc.) no two of which are identical. Much of the original door and window hardware also remains throughout the house.

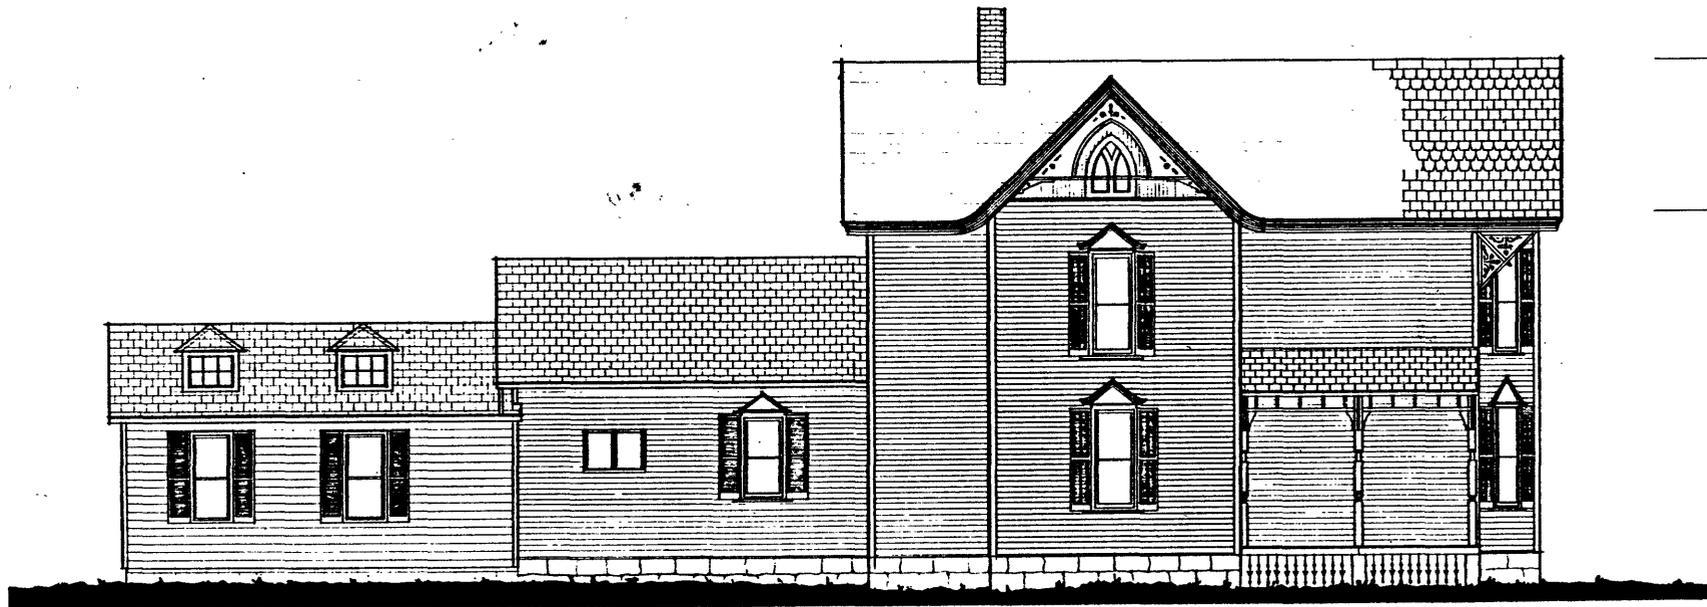
DESIGNED:	SUB SHEET NO.	TITLE OF SHEET	DRAWING NO.
DRAWN: CRAIG CURTIS		WEST ELEVATION	644 60,023
TECH. REVIEW:		EXISTING CONDITIONS APRIL, 1982	PKG. NO.
DATE: / /		DANIEL TILDEN HOUSE	SHEET
		CUYAHOGA VALLEY NATIONAL RECREATION AREA	10
			OF 11

- 26'-10"
- 21'-5" 2ND FLOOR
- 11'-2" 2ND FLOOR
- 8'-0" 1ST FLOOR

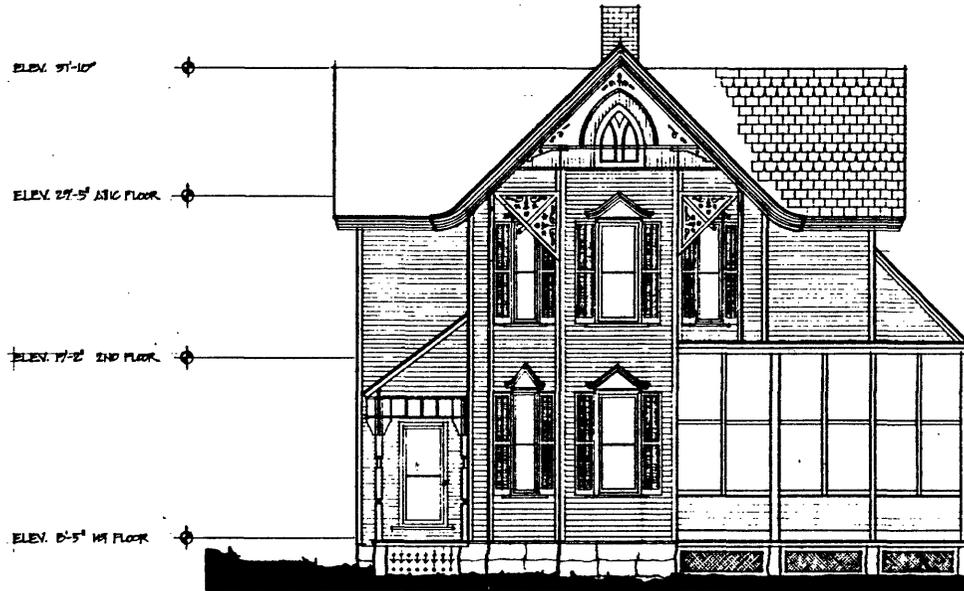
1 SOUTH ELEVATION
SCALE 1/8" = 1'-0"

- ALL ROOFS SLATE EXCEPT GARAGE
- CHIMNEY IN NEED OF REPAIR
- VARIOUS EXTERIOR DETAILS IN NEED OF REPAIR
- BARNSTONE FOUNDATIONS
- ALL GUTTERS & DRAINSPOUTS IN NEED OF REPLACEMENT

The roof of the house is slate. The original portion of the building features a subtle imbrication of alternating rows of rectangular and hexagonal slates; this decorative pattern of roof slates is repeated in the 1888 addition. Asphalt shingles cover the roof of the garage. The exterior of the entire structure is covered with horizontal coved shiplap siding. The foundations of the house are large blocks of coursed sandstone; the garage foundation is concrete.

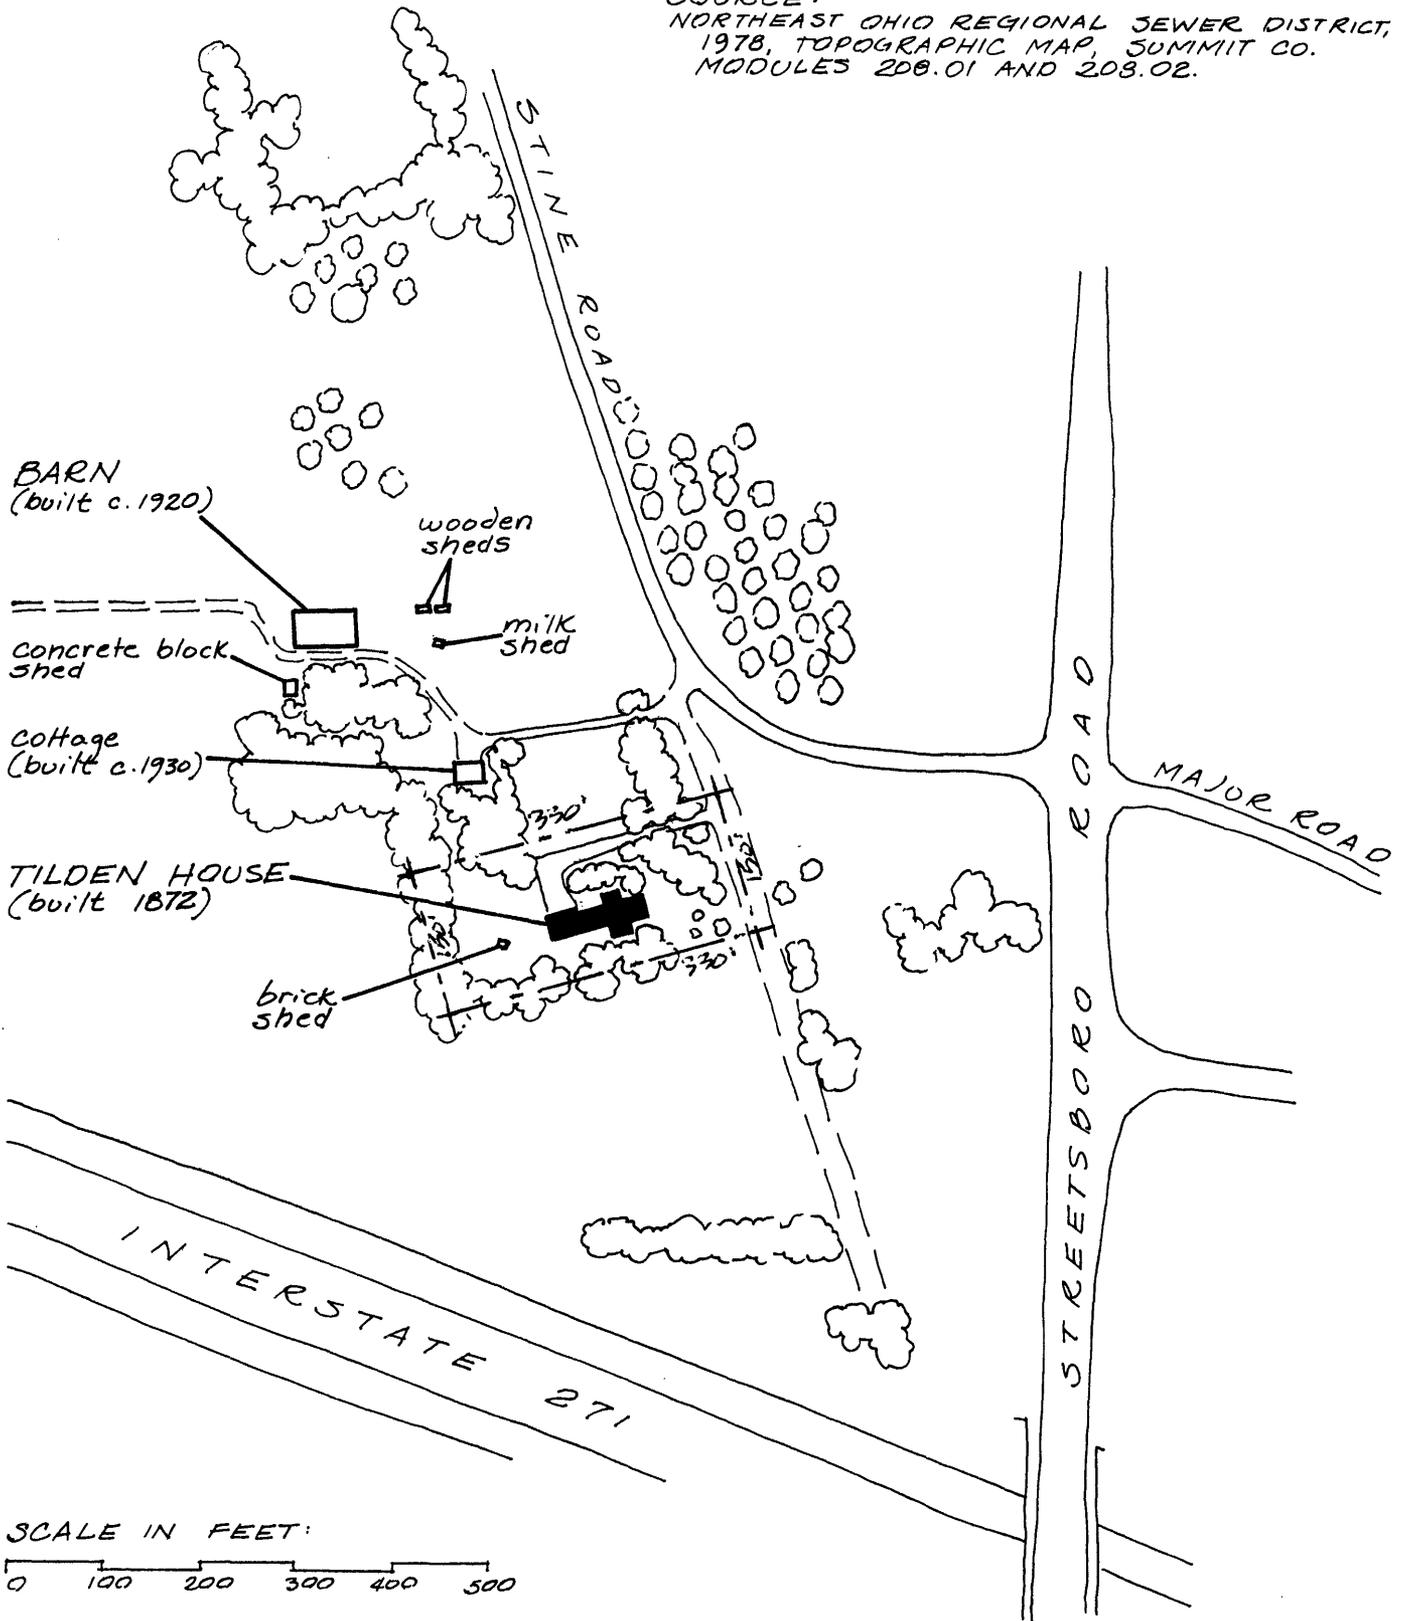
DANIEL TILDEN HOUSE - SITE PLAN

SOURCE:
NORTHEAST OHIO REGIONAL SEWER DISTRICT,
1978, TOPOGRAPHIC MAP, SUMMIT CO.
MODULES 208.01 AND 208.02.
